TEST REPORT

Report No.: HC60263/2006
Page: 1 of 5
Date: July 3, 2006

Product Description: Electromagnet Locks
Style/ Item No.: GL-1200/ No.1;
EM-750/ No.1;
10001ST/ No.1
Manufacturer/Vendor: Gianni Industries Inc.
Country of Origin: Taiwan
Quantity: Total 3 pieces

1. Waterproof test

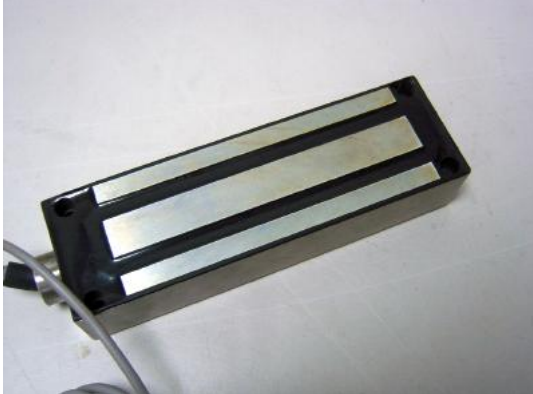
<p>1. Appearance of specimen: GL-1200</p>	<p>2. Functional check: GL-1200</p>

Check Item	Functional check
Style/ Item No.	
GL-1200/ No.1	Normal
EM-750/ No.1	Normal
10001ST/ No.1	Normal

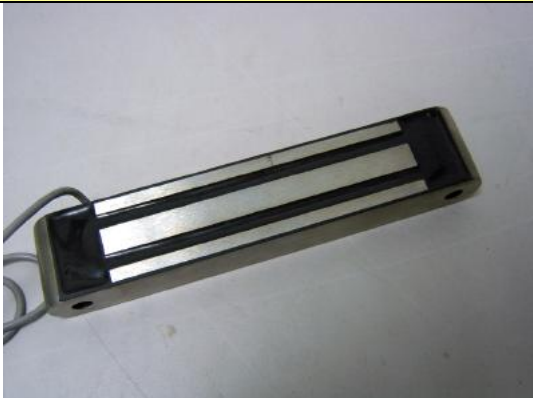
<p>3. Appearance of specimen: EM-750</p>	<p>4. Functional check: EM-750</p>

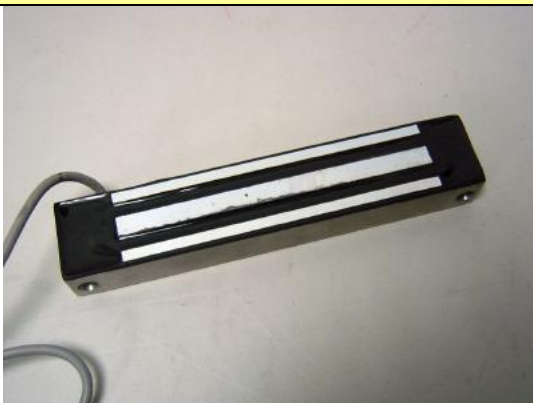
<p>5. Appearance of specimen: 10001ST</p>	<p>6. Functional check: 10001ST</p>
